Report No. 8926-159

Material - Magnesium - AZ91 Casting

Evaluation of Non-Destructive Inspection Procedures

REPORT NO. 56-216
SPEED-BRAKE CASTING. 8-73673EVALUATION OF

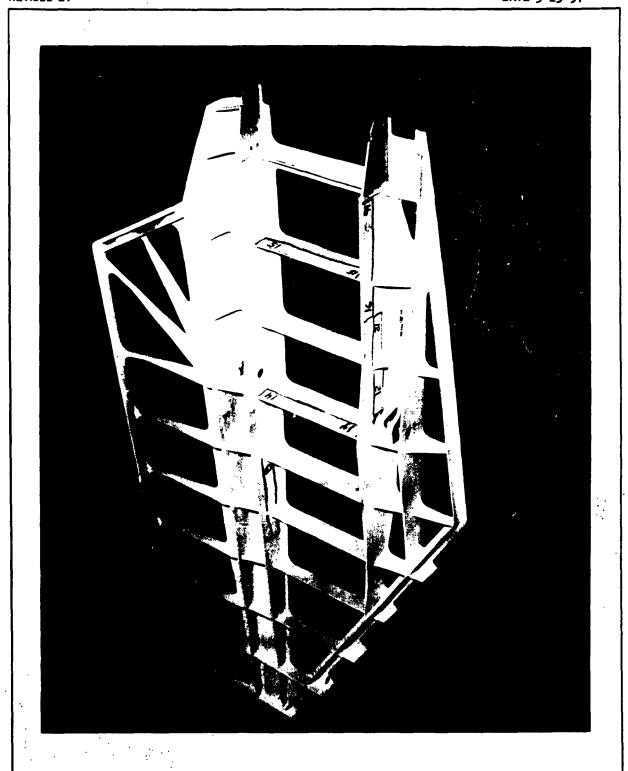
FIGURE 2. PART NO. 8-73673. X-RAY NO. H7315-1 (@ UPONS 12-17)

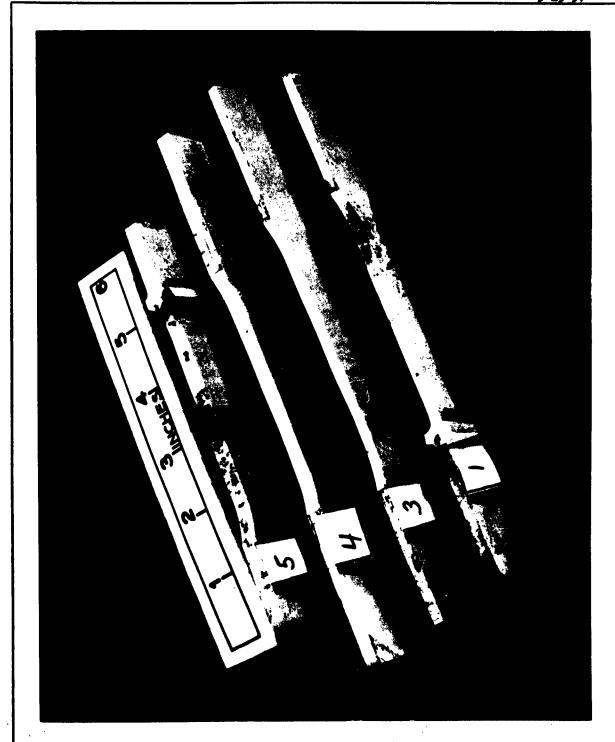
FIGURE 4. COUPONS 1, 3, 4, & 5. (SHOWING DYE INDICATIONS)

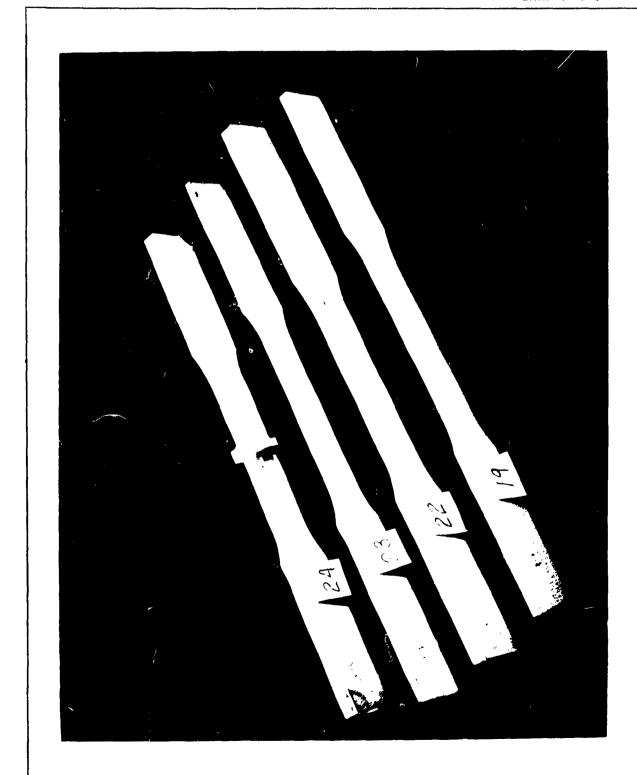
FIGURE 8. 00UPONS 19, 22, 23, & 24

(SHOWING DYE INDICATIONS)

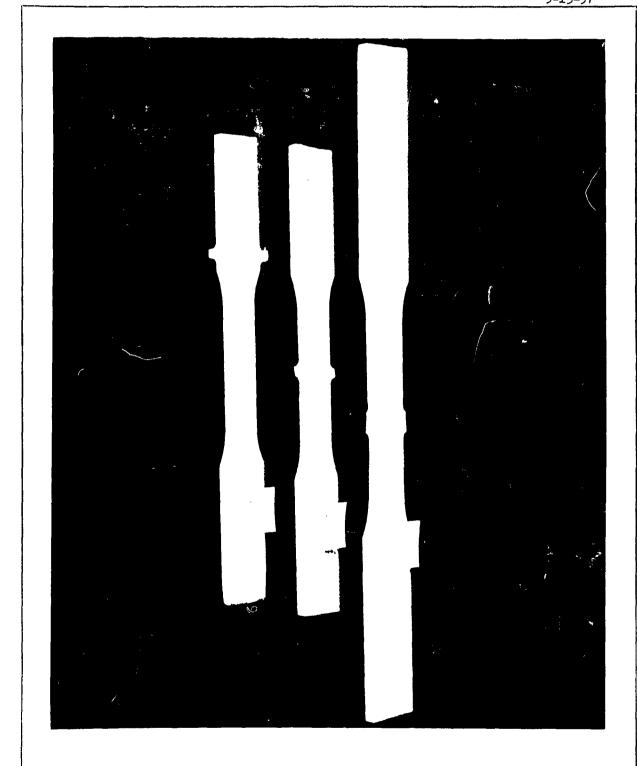
FIGURE 10.

(SHOWING DYE INDICATIONS)
